Spring Lake Borough Pazienza Park Tree Assessment Report

February 25, 2019

Shelterwood Forest Managers, LLC
5 Wildwood Way
Freehold, NJ 07728
William F. Brash Jr., Forester
NJ Approved Consulting Forester
Licensed Tree Expert, LTE #375

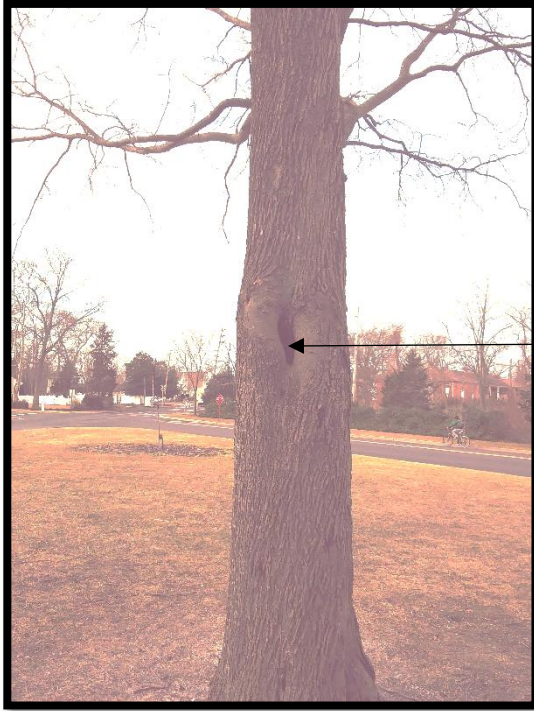
1. *Carya tomentosa*, Mockernut hickory, 25" dbh, 50' in height.

This tree showed extensive decay as shown by the open trunk wound seen in the picture. This tree also displayed decay in the roots, structural limbs and branches greater than 2 inches. The risk assessment determined that this tree should be removed.

← Extensive trunk decay.

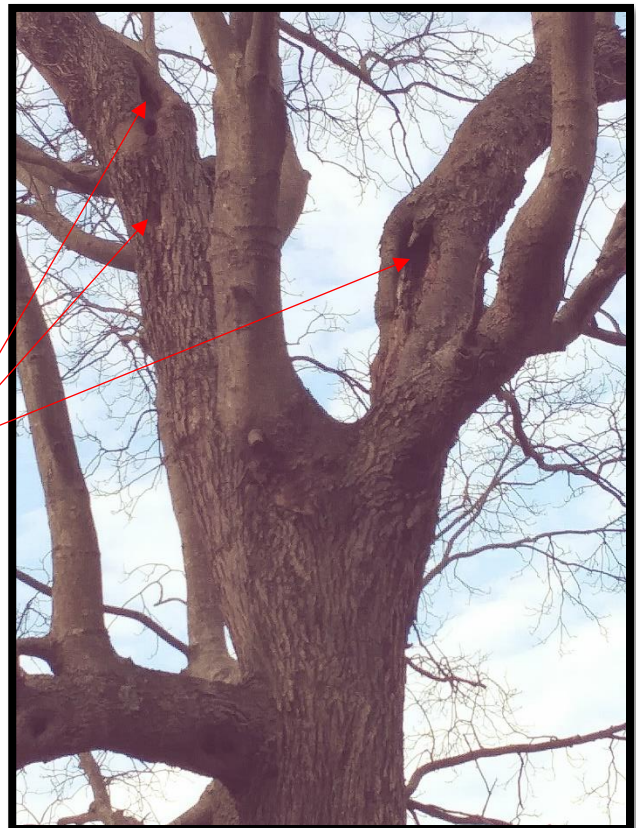
Unusual branch architecture, extensive decay in structural limbs in this the same Mockernut hickory. This tree is a hazard.

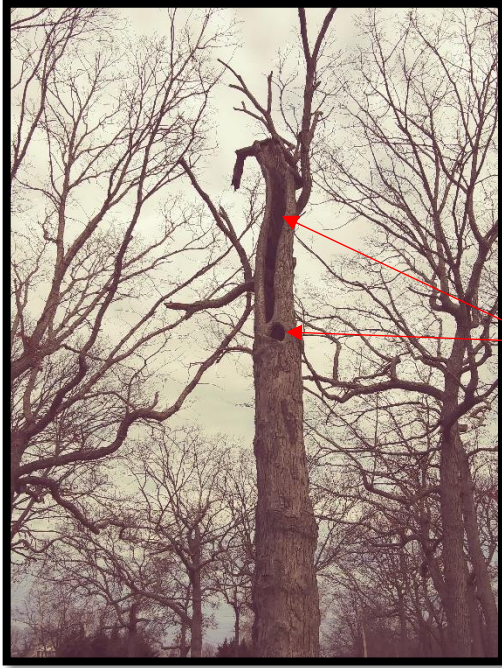
2. *Quercus alba*, White oak 20" dbh, 20' in height. This tree appeared to suffer a lighting strike that resulted in extensive decay in the trunk, structural limbs and branches more than 2" in diameter. This tree also displayed fungal root conks (fungi fruiting bodies) at the base of the trunk.

Extensive trunk decay in this white oak may have begun as the result of a lighting strike or trunk failure in a wind event.

The risk assessment for this tree was to recommend removal

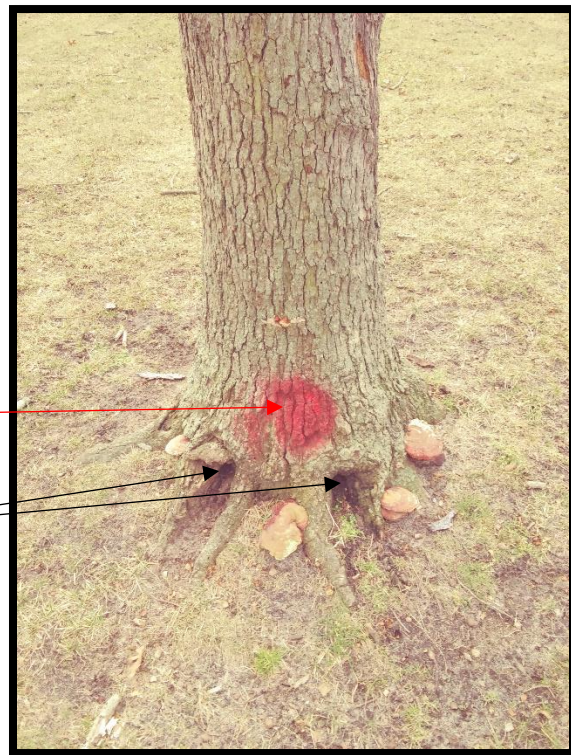
This tree is painted red and recommended for removal.

Trunk decay down to the ground is clearly seen in this 20" dbh White oak.

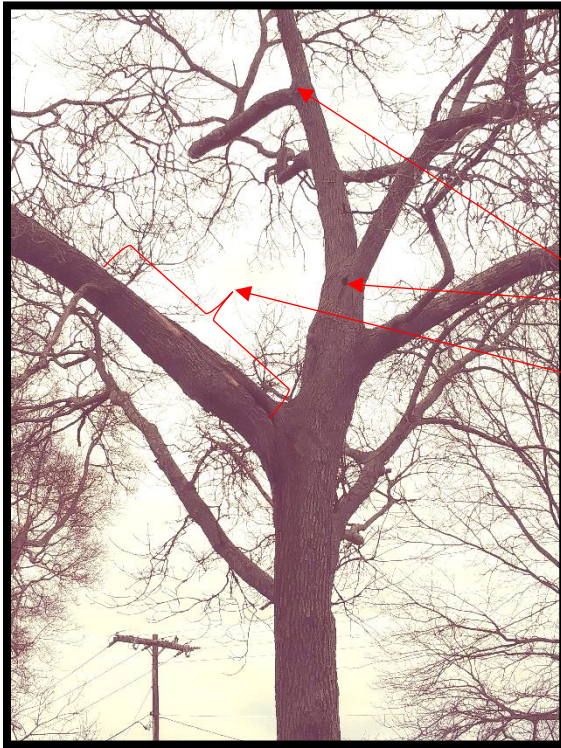
3. *Quercus velutina*, Black oak. 22" dbh, 62 feet in height.

This tree showed extensive decay in the main structural branch along with decay higher up in the main trunk as well as unusual architecture probably due to old branch decay and subsequent loss.

This tree shows decay high up in the main trunk.

This tree's main structural branch shows extensive decay.

Pruning the main structural limb would have left the tree with an even more unusual architecture and significantly unbalanced crown subjecting the tree to the increased likelihood of wind throw.

The recommendation for this tree was removal.
